# INSPECTION REPORT

North Point

390 CKDS

Jayco

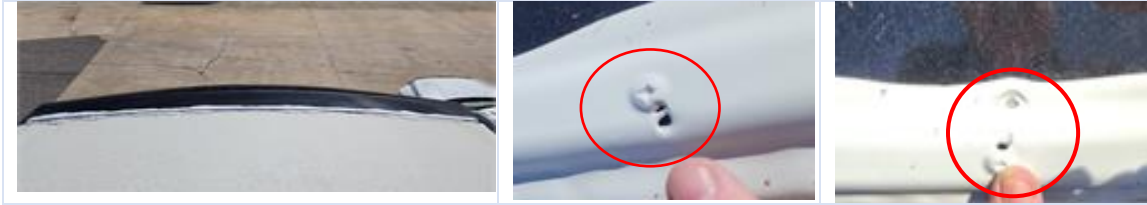
| FRONT CAP JOINTS & SEALS CONDITION | ACCEPTABLE |

Holes in the lap-sealant covering the screws in the trim over the front cap/roof joint. Recommend evaluation and repair by a qualified RV technician.

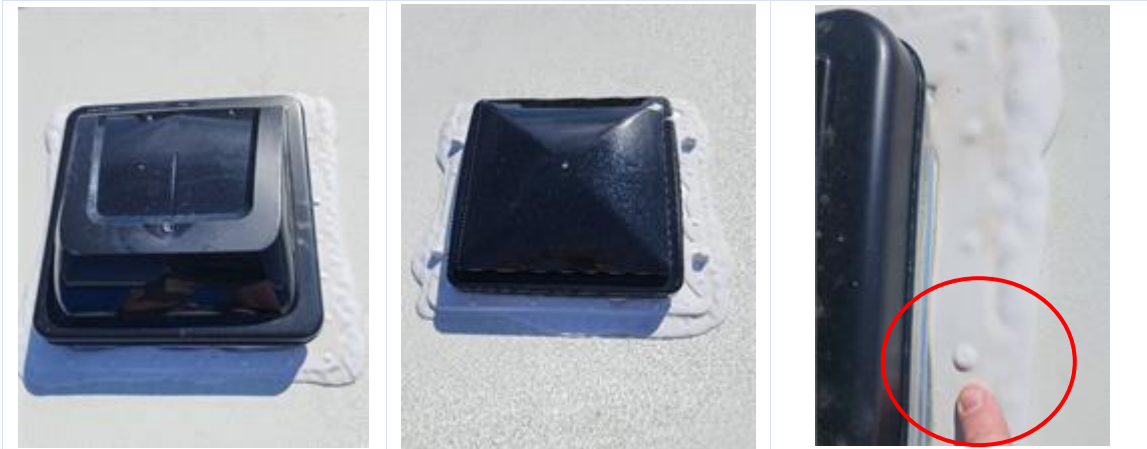
**EXTERIOR VENT CONDITION****ACCEPTABLE**

**An attachment screw on the side of the rear exterior vent needs to be tightened down further and resealed. Recommend evaluation and repair by a qualified RV technician.**

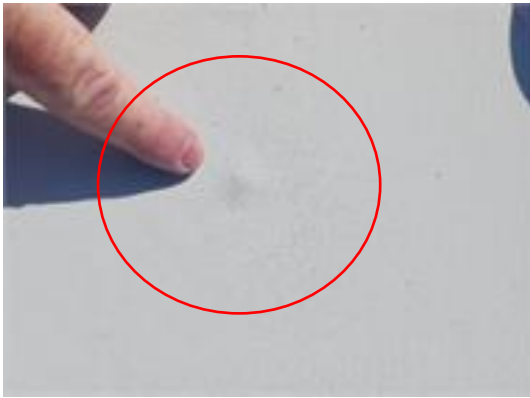
OTHER ITEMS

Screws attaching the plywood roof underneath the rubber roof membrane are backing out in multiple places across the roof.

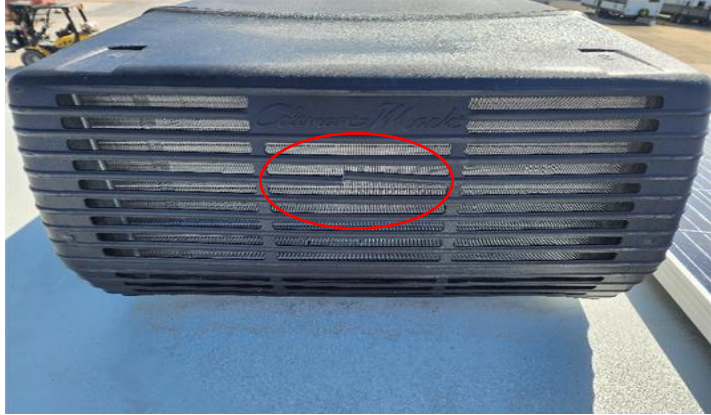
AIR CONDITIONER (SHROUD & EXTERIOR COILS)

The middle A/C shroud has a broken section covering the exterior coils.

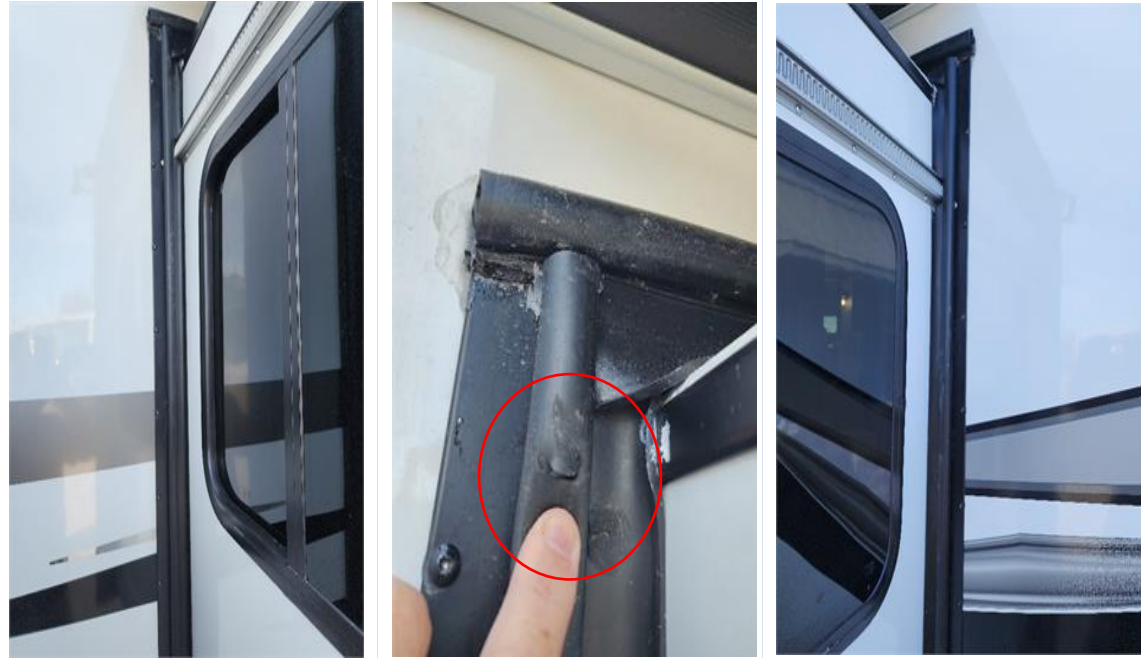
## SEALS, SWEEPS AND GASKETS

Curbside rear slide-out, front side gasket has a tear. Recommend evaluation and repair by a qualified RV technician.

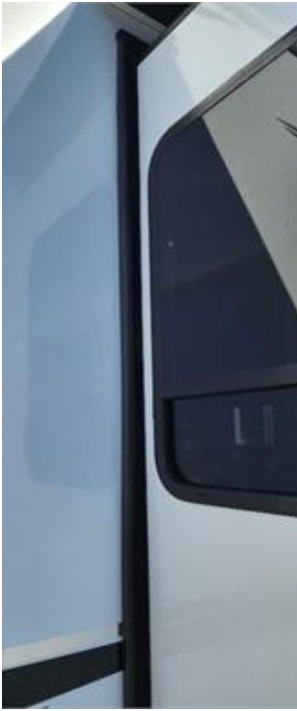
## SEALS, SWEEPS AND GASKETS

Curbside slide-out, front side seal does not touch the slide-out when extended which could allow water and wind intrusion. Recommend evaluation and repair by a qualified RV technician.

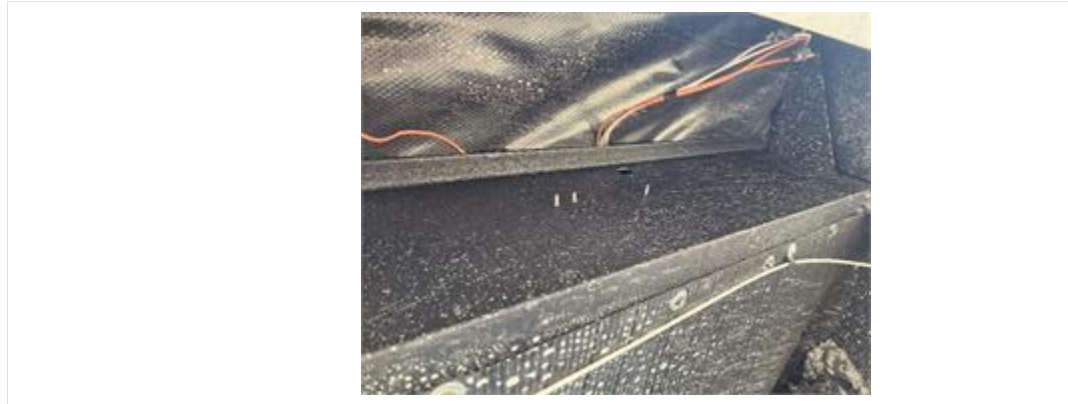
FRAME CONDITION ACCEPTABLE

Drop-frame both front and rear.

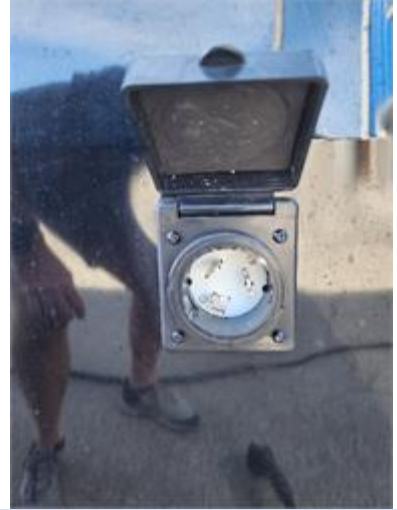
| POWER CORD CONDITION | ACCEPTABLE |

Power cord attachment to the side of the RV needs to be rotated to allow the power cord to attach, align and hang correctly. Recommend evaluation and repair by a qualified RV technician.

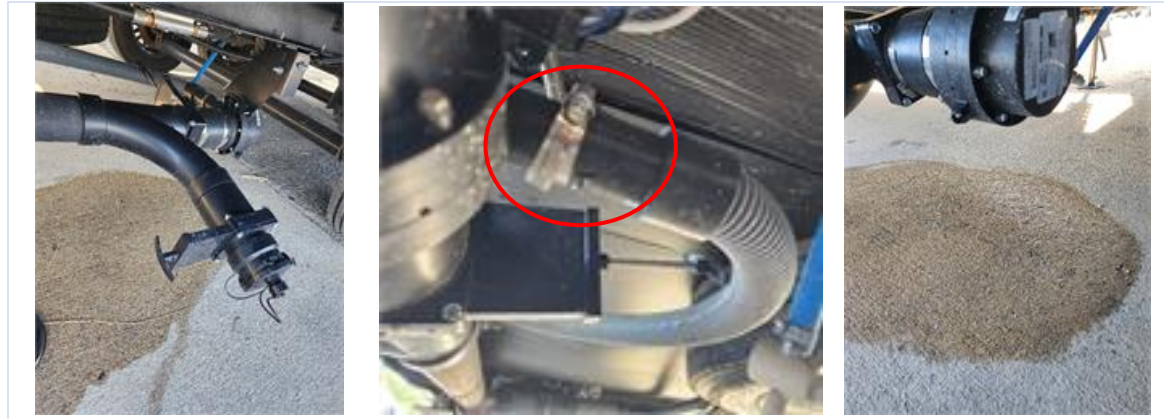
| TANK, VALVE OR LINE LEAKS | YES |

**A leak was observed on the piping to the macerator attachment. Recommend evaluation and repair by a qualified RV technician.**

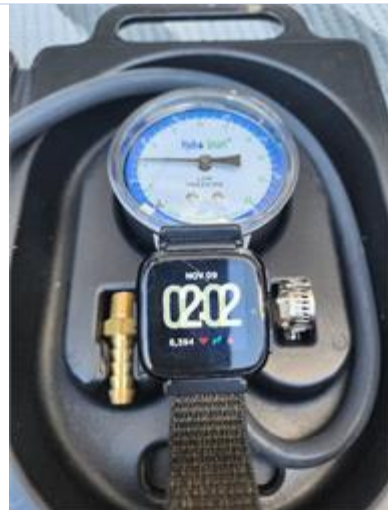
LP system held 8" of water column for 5 minutes.

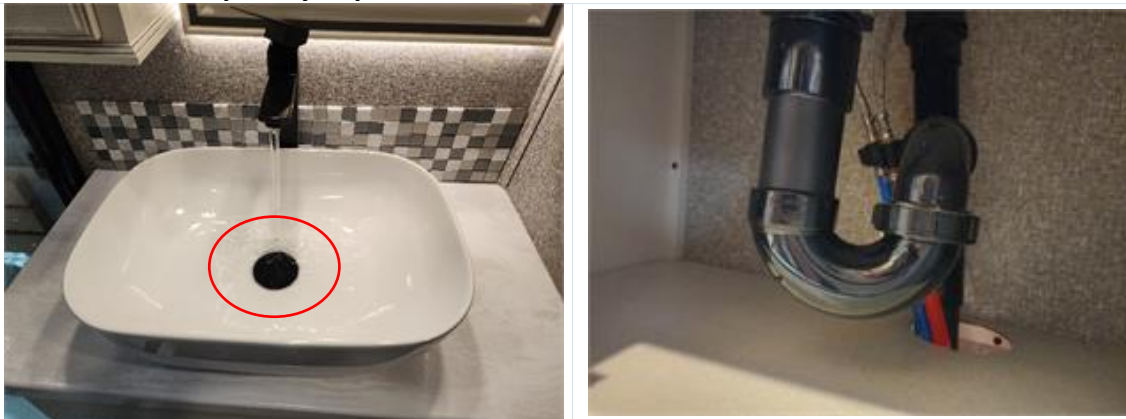
**BATHROOM CABINETS AND COUNTERTOPS** ACCEPTABLE

**Bathroom sink will not hold water. The stopper doesn't seal properly. Recommend evaluation and repair by a qualified RV technician.**

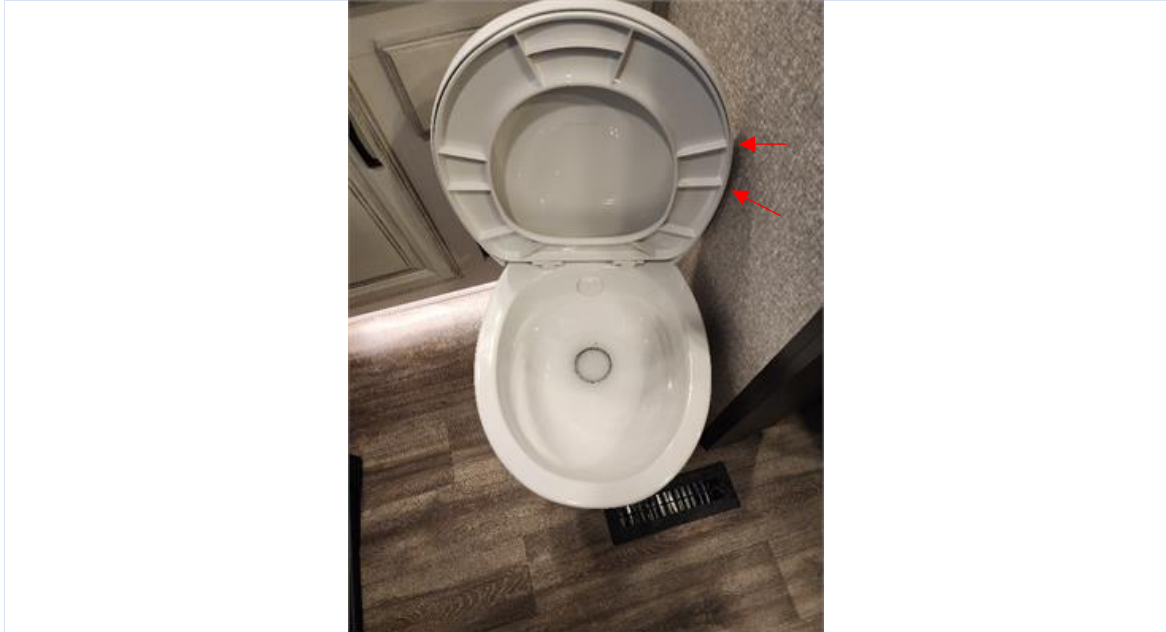
**Toilet lid contacts the wall and will not open fully. Recommend evaluation and repair by a qualified RV technician.**
